Manhole Inspection Summary

Manhole # S11SS1012MH

Insp Date: **4/12/07 10:46 AM**

Location Address: **5002 LEVINDALE RD**

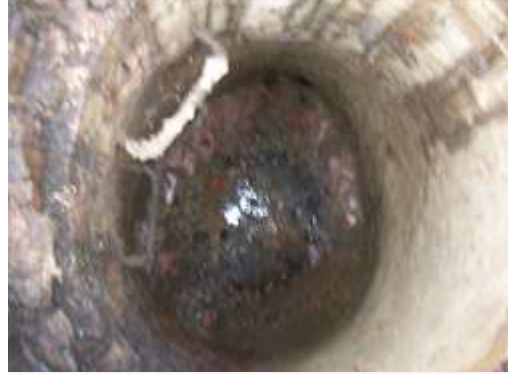
Top View

Channel debris.

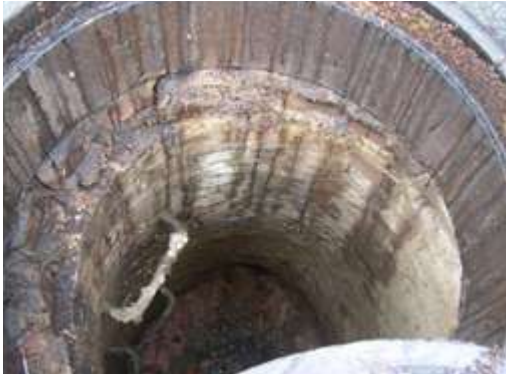
Defect

☒ **Leaks**

Condition: ☐ Sound ☐ Cracked ☐ Root Intrusion ☒ **Loose Brick** ☒ **Deteriorated**

Infiltration: ☐ None ☒ **Joint** ☐ Cracks ☐ Mortar ☐ Roots ☒ **Wall**

Frame leaks. Frame offset. Adjustment deterioration, loose brick and infiltration. Corbel and Barrel infiltration.

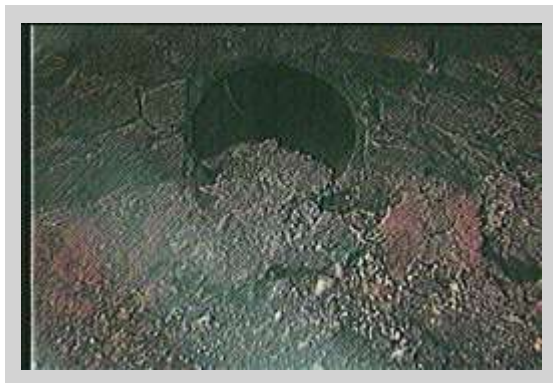
Pipe Out @ 12 O'Clock

Condition: ☐ Sound ☐ Cracked ☐ Root Intrusion ☐ Loose Brick ☒ **Deteriorated**

Infiltration: ☐ None ☐ Joint ☐ Cracks ☐ Mortar ☐ Roots ☒ **Wall**

Barrel deterioration and infiltration.
